ZINGA ON REBARS

THE PROTECTION OF REBARS WITH ZINGA

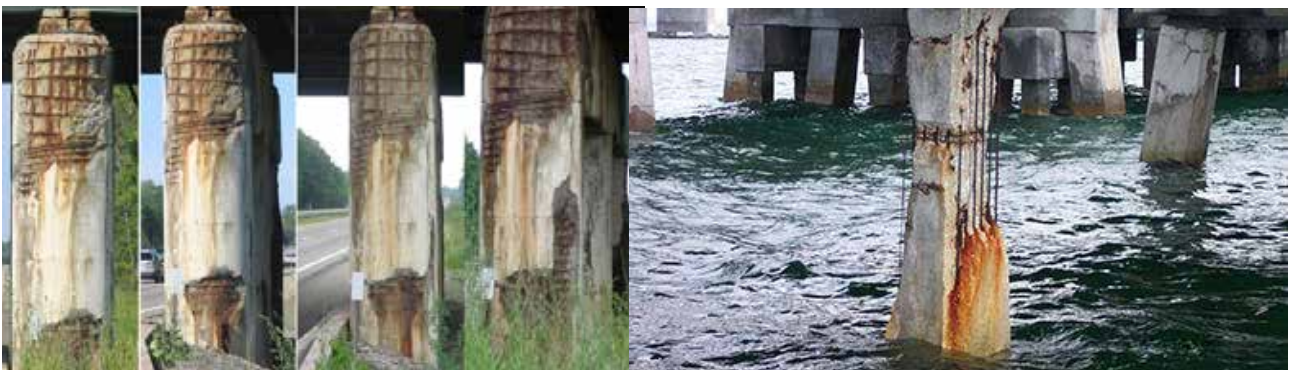
The rust can form up to 2 times the volume of the initial steel and can cause cracking of the concrete or even the complete destruction of it.

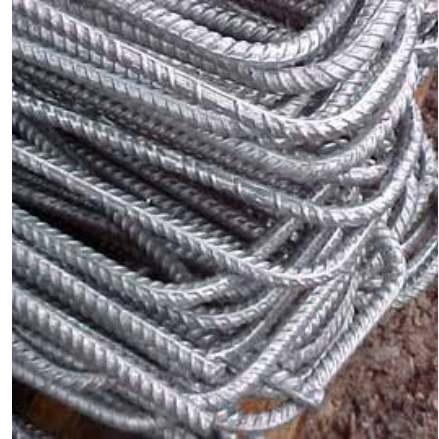
HDG Rebar

The second solution was hot-dip galvanisation, but this is still far from perfect. Cracks caused by the bending of the rebars, can easily destroy the galvanising layer. Another problem is that hot-dip galvanised rebars do not provide enough adhesion for the concrete. Moreover, the rebars need to be galvanised in a specialised workshop, equipped with a galvanising bath, which means that the rebars have to be restricted in size. This will cost time and money due to the distance and the transport to this galvanising workshop, which can be very expensive in some parts of the world.

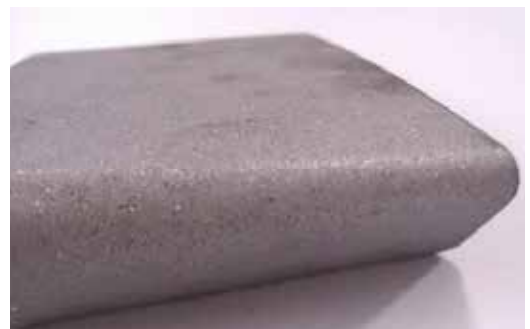
ZINGA has been applied at a layer thickness of 60 µm DFT on test panels and bent by a mandrel tester at 23°C and 50% RV. The diameter of the mandrels are 32 mm, 25 mm, 20 mm, 16 mm, 13 mm, 12 mm, 10 mm, 8 mm, 6 mm, 5 mm, 4 mm, 3 mm and 2 mm.

ZINGA showed no cracks when bending on a cylindrical mandrel with a diameter of 12 mm.

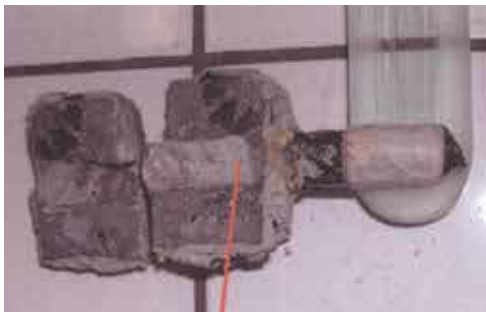
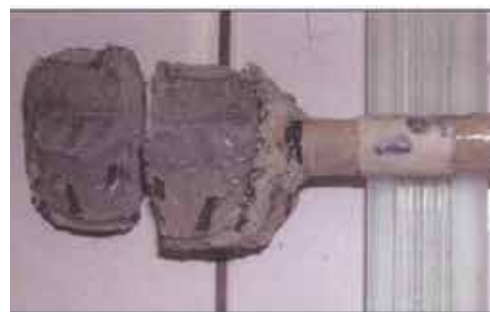
It is clearly more difficult to cleave the rebar bloc containing the steel rod protected with ZINGA. The adherence of the concrete to the Zinganised rod is better. The actual cleavage happens in the concrete (in contrast to the other two rebars, which cleaved neatly between steel and concrete), which indicates a strong adherence.

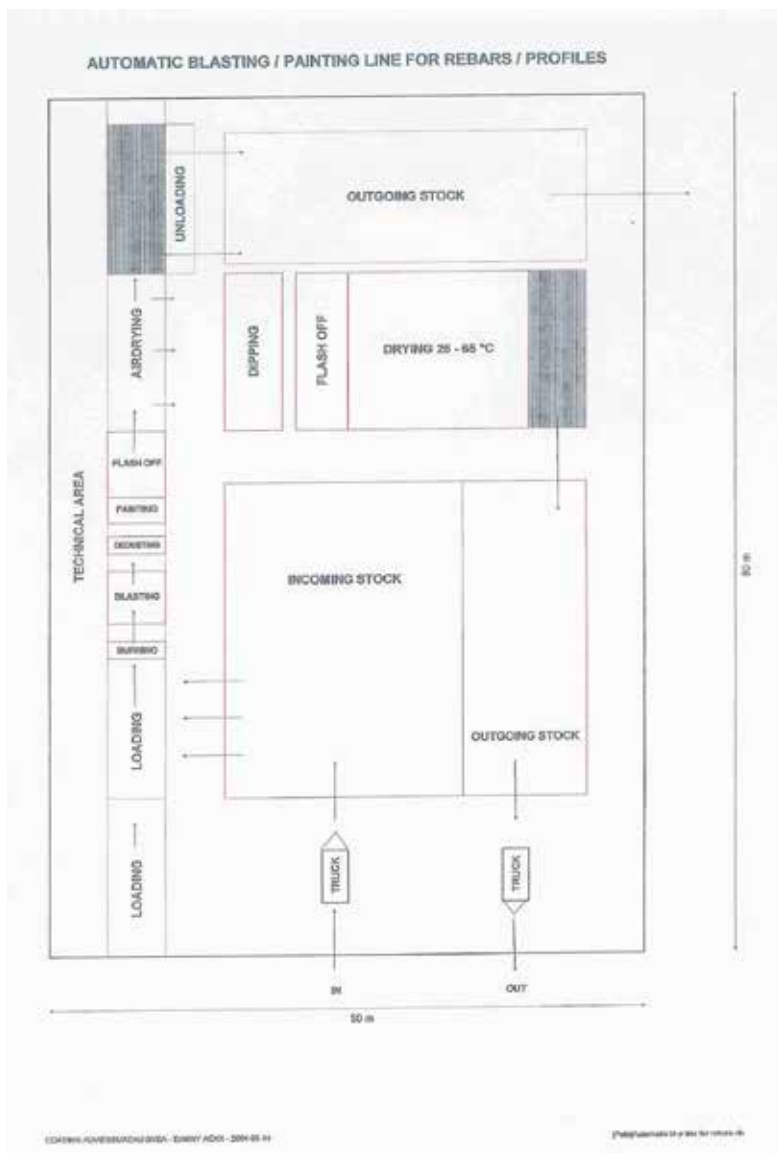
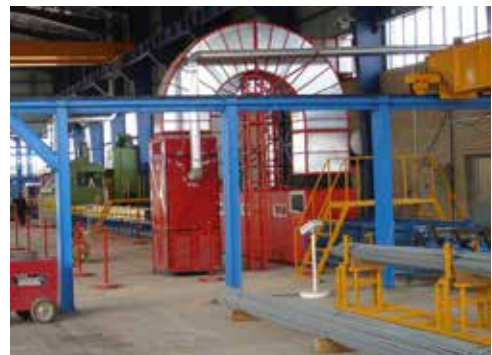
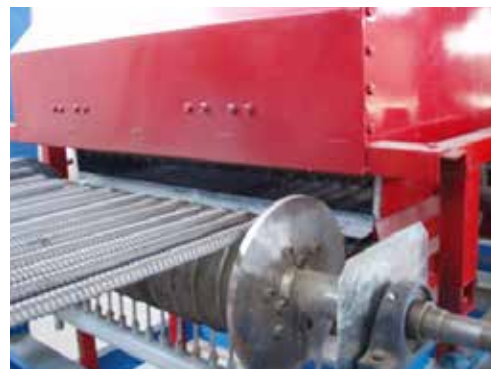
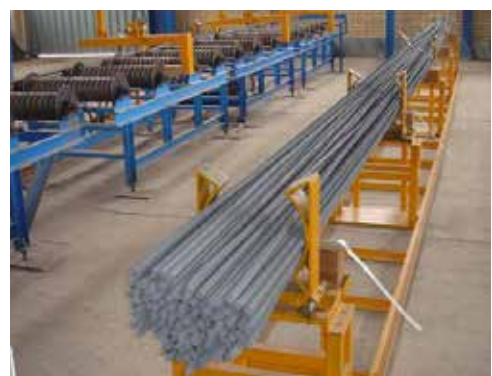
1. Incoming uncoated rebars are stocked above the feeding line, up to a quantity of 50 tons.
2. All rebars are manually handled onto an automatic side conveyor. Up to 16 rebars per charge.

3. The side loader is automatically transferred to the treatment line. The 16 rebars are lifted and positioned in the treatment line.
4. The rebars are then heated. The heat will loose the mill scale from the underlying steel. The surface temperature of the rebars mounts up to 60°C.

5. The rebars automatically enter the wheel blast machine. Automatic (electrically driven) wheel blasters are grit-blasting the rebars to cleanliness degree SA 2,5 and roughness degree 30 to 40 µm Rz. The surface temperature of the rebars is still too high after blasting.

6. The rebars are then pushed through brushes in order to remove the dust and grit, this is followed by dedusting with clean air.
7. The rebars automatically enter the temperature equalising area. In order to avoid temperature stresses in the steel, the inner and outer temperature of the rebars is equalised.

8. The rebars pass through an automatic spray booth in which two reciprocators are spraying the Zinga.
9. The rebars pass through a drying oven.
10. The rebars are transferred automatically to the end station for unloading.
